12 Fall from baker-style scaffold – Inspection #1159883

A **29 year old male** employee was fatally injured when he fell 5’ feet 5” inches from a baker scaffold striking his head on the concrete floor. On the day of the accident, the victim was working alone, finishing drywall from a baker scaffold, when fellow workers heard a noise. They found the victim unresponsive and bleeding next to the scaffold. There were no witnesses to the accident. During the investigation and interviews, it was determined the caster/wheel locks on the baker-style scaffold were not engaged which could have allowed movement of the scaffold causing the employee to lose his balance and fall. The employer had not provided scaffold training by a qualified person, and did not have a competent person to inspect the scaffolds.

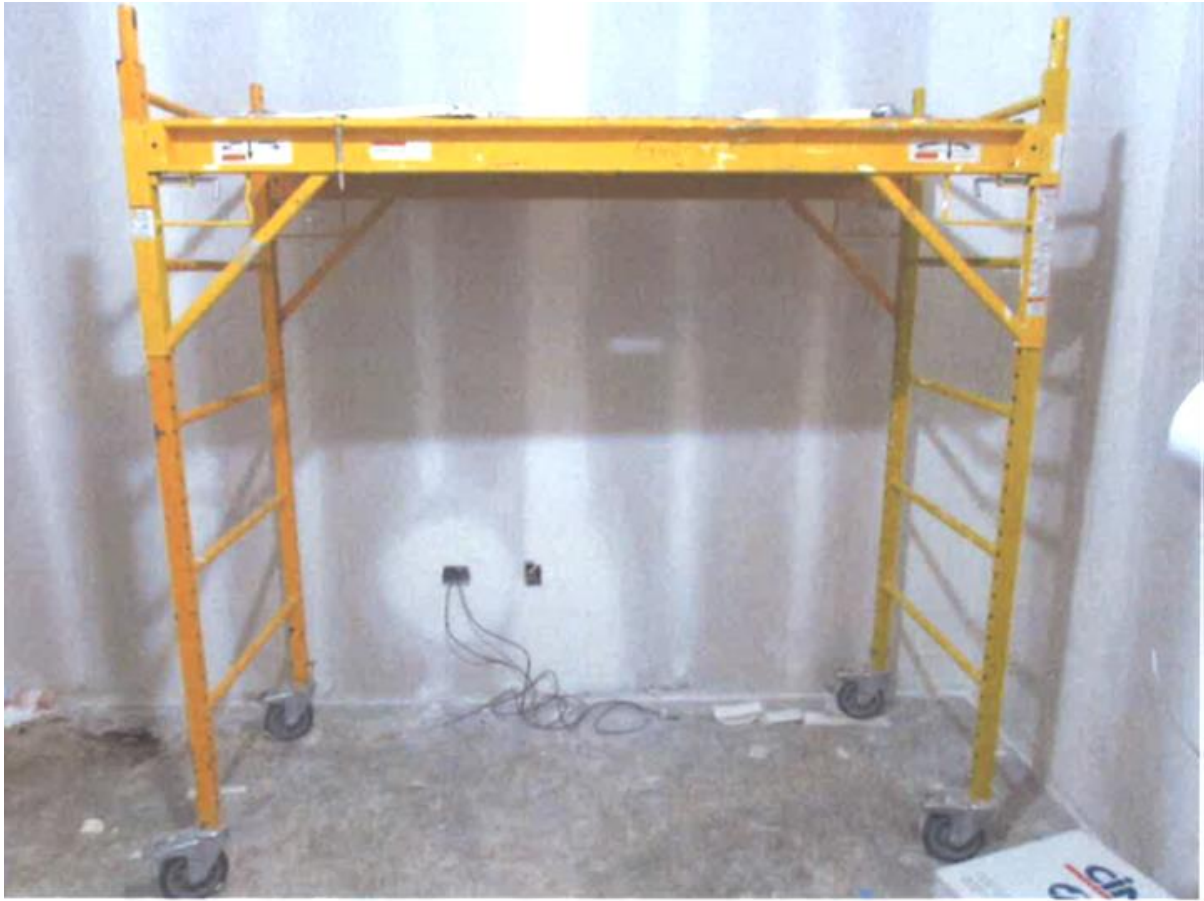
Photo 1 of 2 – Example baker-style scaffold. During interviews, it was determined the wheels (left side when facing forward) on the baker scaffold had not been locked. The incident scene was held until a TOSHA inspection was initiated the next day.

29 CFR 1926.452(w)(2)	Scaffolds casters and wheels were not locked with positive wheel and/or wheel and swivel locks, or equivalent means, to prevent movement of the scaffold while the scaffold was used in a stationary manner. In that the caster/wheel locks on a baker-style scaffold, located in Room #B15, were not engaged to prevent movement of the scaffold while in use on or about 6/29/16.
-----------------------	---

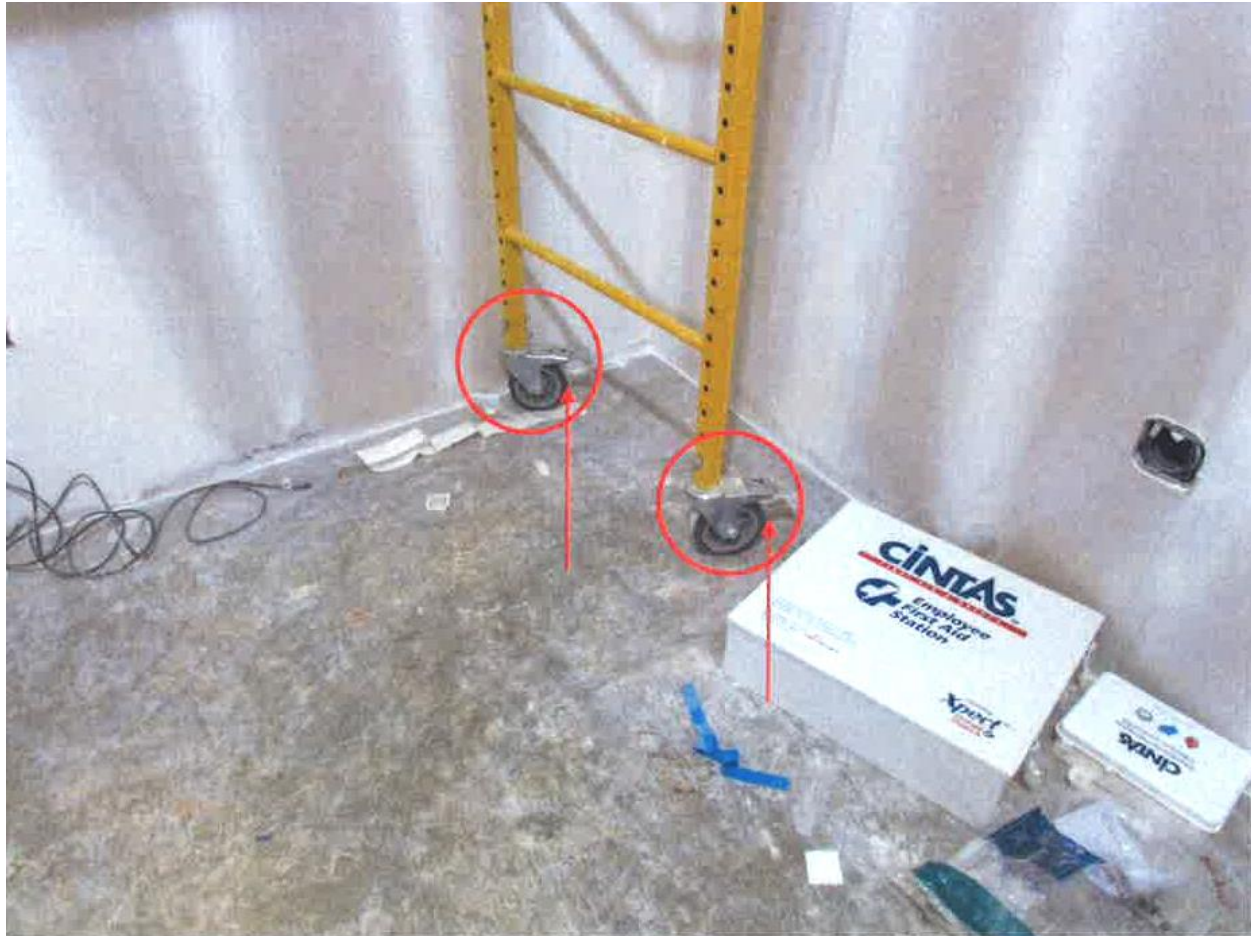
Photo 2 of 2 – Demonstrates the wheels (right side when facing forward) on the baker scaffold had not been locked also.
