## **10 Crushed by baler – Inspection #1225825**

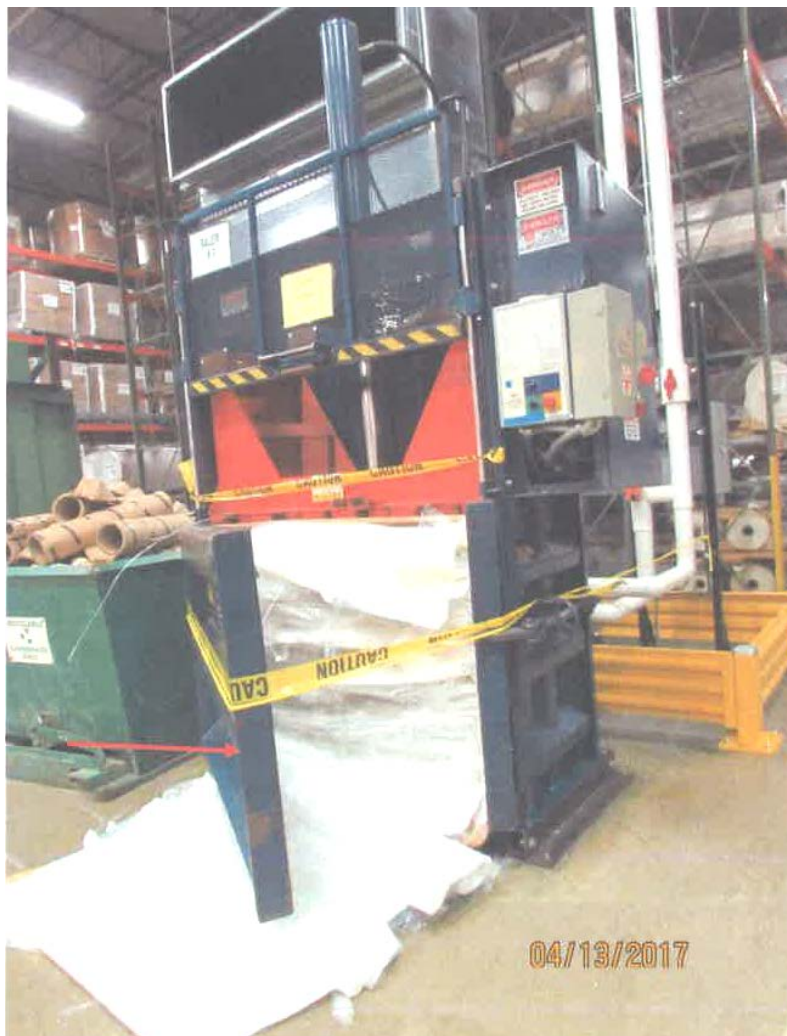
A **51 year old male** employee was fatally injured when his head was crushed by the chamber door of a baler. On the day of the incident, the victim and another employee were operating a Cram-a-Lot vertical bailer with press-head, Model BV-60-B. The operation required the employees to load the chamber with plastic, manually close the chamber door, secure the latch, activate the press-head to compress the plastic, and finally bale the plastic cake with baling ties for disposal. At one point during the day, the employees over loaded the baler and the chamber door would not shut. The chamber door must shut and the latch secured before activation of the press-head. In efforts to force the chamber door shut, employees used a walk behind forklift with a carpet pole attachment to apply pressure to the door. While the victim tried to push the plastic into the bailer with his hands, he instructed the other employee to push the chamber door with the forklift carpet pole attachment. As the forklift forced the chamber door to close, the victim's head was crushed in between the chamber door of the baler and the baler itself.

Photo 1 of 1 – The chamber door (red arrow) stuck the victim’s head when a walk behind forklift was used to force the door shut.

TCA 50-3-105(1)	<p><b>Each employer did not furnish to each of its employees conditions of employment and a place of employment free from recognized hazards that are causing or are likely to cause death or serious injury or harm to its employees.</b></p> <p>In that employees were exposed to struck-by hazards while operating the Cram-a-lot vertical baler model VB-60-B improperly in the following instances: a) A forklift was being used to aid in closing the baler door b) the bailer was being overloaded with plastic c) employees were not instructed and trained on safe work methods, including procedures provided by the manufacturer, before being assigned to operate the baler. Among other methods, one feasible and acceptable abatement method to correct the hazard would be to follow the manufacture's recommendations in regards to the standard model Bale Weight.</p>
-----------------	---
