Overtured skid steer—Insp # 1665536 **Rodriguez Paving and Foundation**

A 20 year old male employee was spreading gravel using a skid steer near a portion of a roadway supported by a retaining wall when the wall collapsed causing the skid steer to tumble approximately 200 feet down a mountain side.

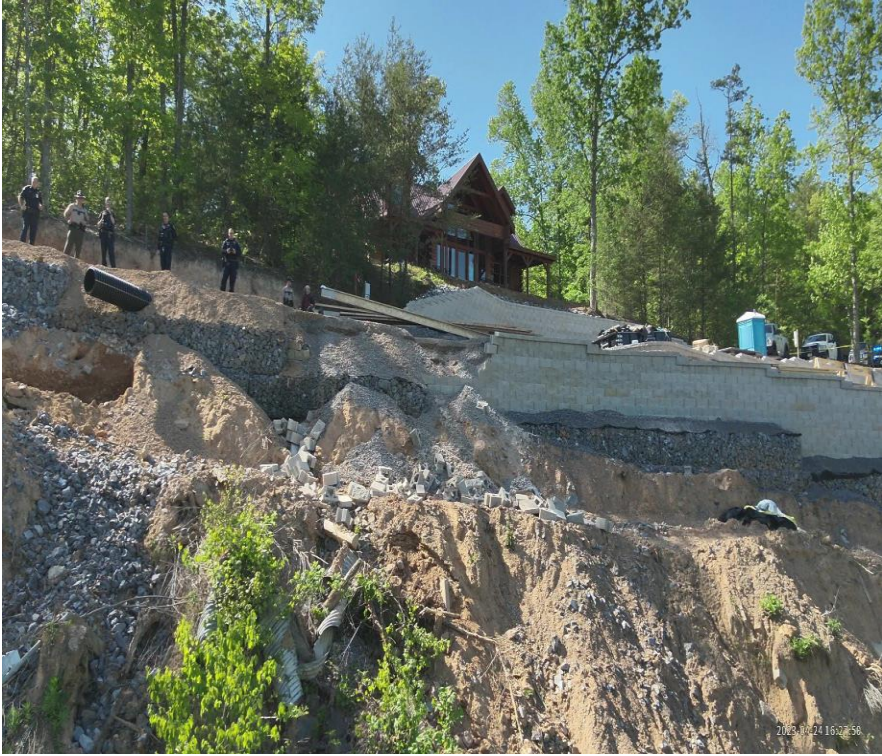
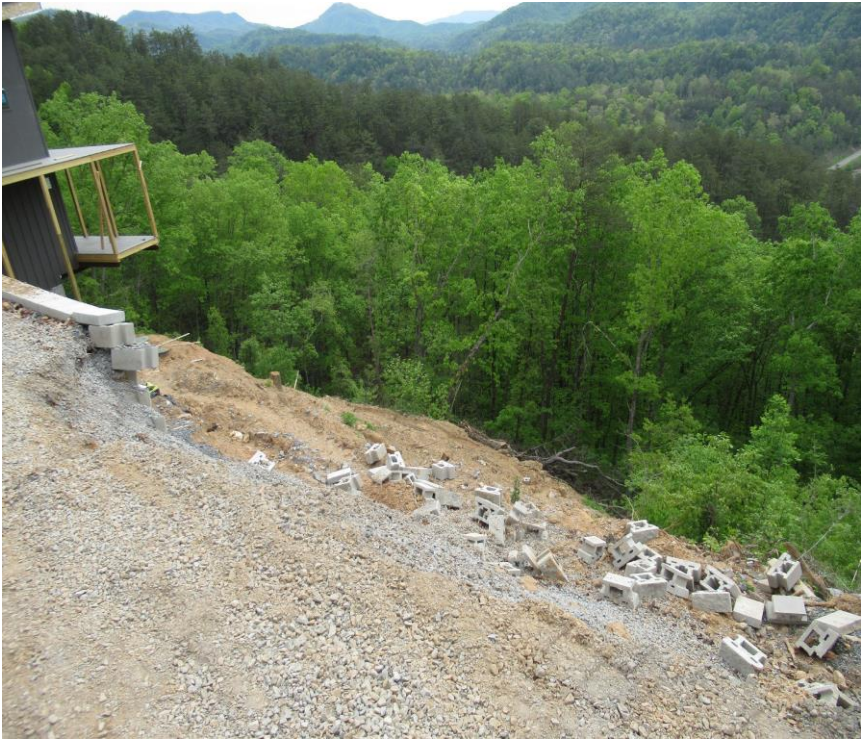
Overtured skid steer—Insp # 1665536 **Rodriquez Paving and Foundation**

It was determined that the driveway leading up to the house had a retaining wall that was sinking over time due to being improperly constructed and the rain-washing out the backfill. The retaining wall had been built without using geogrid to help stabilize the wall this the ground behind it. There was also not adequate drainage behind the wall which led to the backfill washing out and the retaining wall separating as it sank. The retaining wall gave way with the weight of the heavy equipment moving along the top of the retaining wall.
