A 49 year old male employee suffered an Achilles tendon injury when his foot got caught between a pallet and a pallet jack that another employee was using to move material.

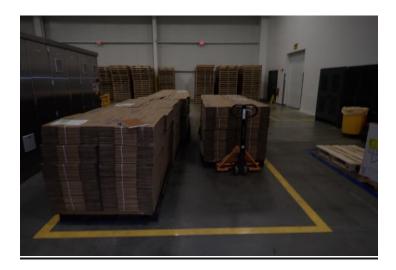
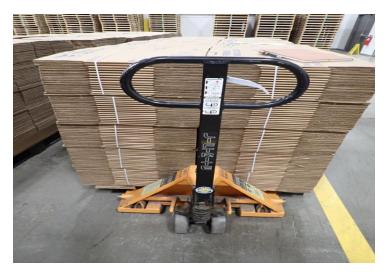
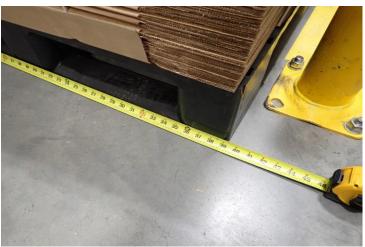
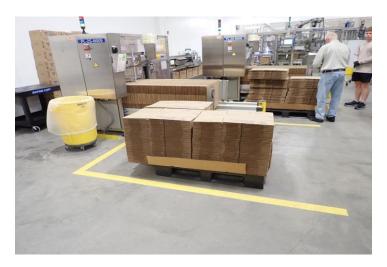
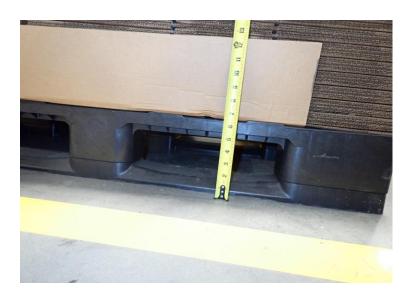
The incident occurred in the area known as the Bio Fine Department, Production Line 2, Pack Out area. The staging area is approximately 20' in length and 8' wide, holding approximately twenty pallets formed in two lines, ten pallets each. Forklifts are used on the east end to deliver pallets of flat-stack cardboard boxes. Manual pallet jacks are utilized to move the pallets from the staging area to pack out Lines 1 and 2 from the west side. The staging area is marked off by yellow high-visibility tape, creating aisles for employees and a manual pallet jack to maneuver through. There is an aisle on all sides of the staging area, except the east end, where forklifts operate on the production area floor. The aisle ways are shared by employees, and a manual pallet jack is used to move material from the staging area to the Palletizer Pack-Out Lines 1 and 2.

The Palletizer Pack-Out line 2 is directly across from the staging area and is separated by a single pallet of stacked flat boxes from the staging area. The single pallet is located on the west side of the staging area, with a yellow line on the production area floor surrounding it on three sides. The aisle between the single pallet and the staging area is approximately 4' wide for employees and pallets that are to be moved by a manual pallet jack to restock Lines 1 and 2 during production. Employees operate the machine by hand to ensure the machine is always supplied with stock during production.

The victim was working in an aisle next to a pallet of flat stacked boxes between the Palletizer Pack-Out Line 2 and Pack-Out staging areas. Another employee was moving a pallet of flat stacked boxes from the staging area with a manual pallet jack. The employee pulled the pallet out of the staging area and started to turn into the aisle way when he noticed the victim behind him trying to move out of the way. The victim's right foot got pinned between the pallet on the floor and the pallet being transported by the pallet jack. He fell backward on the pallet of partially stacked flat stack boxes on the floor of Line 2. The back of his right foot was pinned in the plastic pallet forklift hole of the stationary pallet on Line 2 by the moving pallet.
