A **42 year old male** employee was **struck by** falling product while operating an AGV (automated guided vehicle). This employer produces block, sliced, and shredded cheese products.

Struck by--Insp # 1550303 Bongards' South LLC

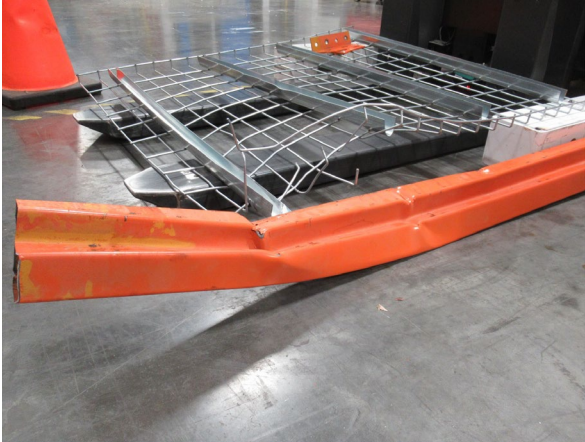
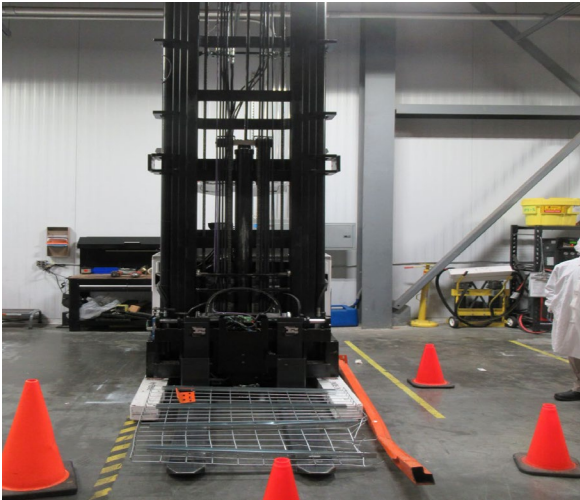
On August 24, 2021, the victim was injured as he attempted to reset a fault on AGV #3 that had stopped in row 9, bay 58, level 4 of the DC warehouse. It was explained that when an AGV shows a fault, the machine stops where it is and what it is doing until the fault is reset. According to fault codes pulled from AGV #3 at the time of the incident, the fault code stopping AGV #3 appeared as a "TC Hold Sec". The code showed because the pallet being raised by AGV #3 did not clear a portion of the racking system and one of the AGV sensors thought something was blocking the pallet's progress into the racking system.

These the "black box" was pulled from AGV #3. The "black box" provided codes and sensor readings from the AGV, along with times in which each code appeared. It is assumed that sometime during the task of placing the pallet into the racking system, contact was made between the AGV and the racking system on level 5 damaging the cross brace which caused approximately 23 cases of cheese to fall on the victim.
