13. Fall into shredder

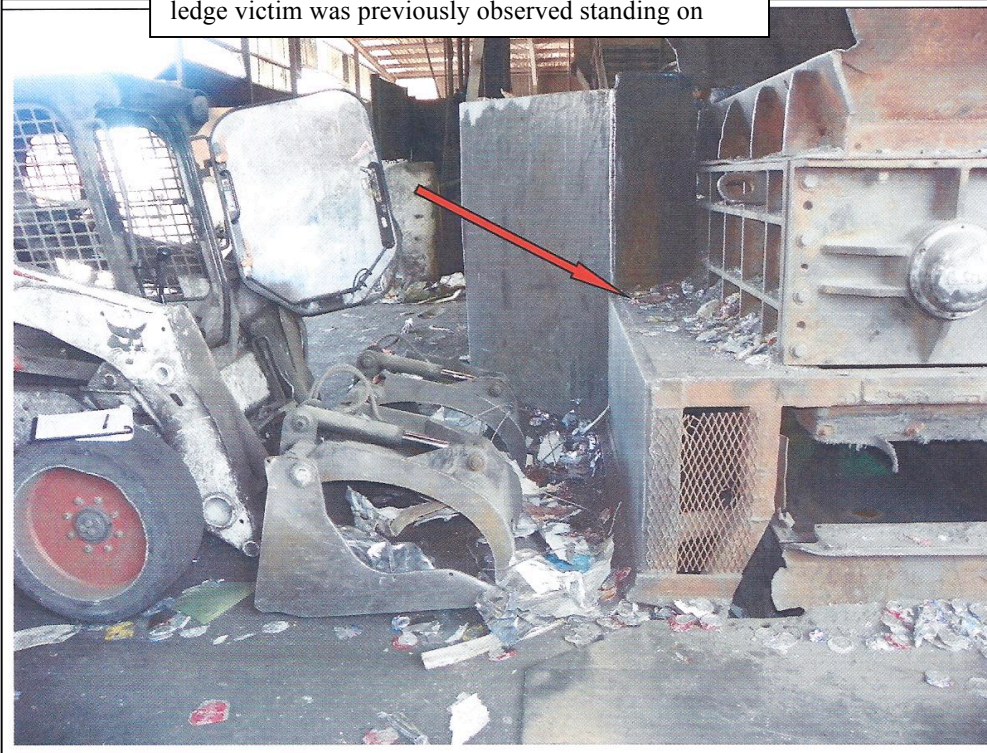
Loading of shredder where fatality occurred showing ledge victim was previously observed standing on

Item 2a 1910.147(c)(4)(i)	Procedures were not developed, documented, and utilized for the control of potentially hazardous energy when employees were engaged in activities while servicing or maintaining equipment.

Item 3 1910.212(a)(1)	One or more methods of machine guarding were not provided to protect the operator and other employees in the machine area from hazards such as ingoing nip points, rotating parts, and unguarded blades. (specifically moving teeth of the shredder and shredded metal parts)

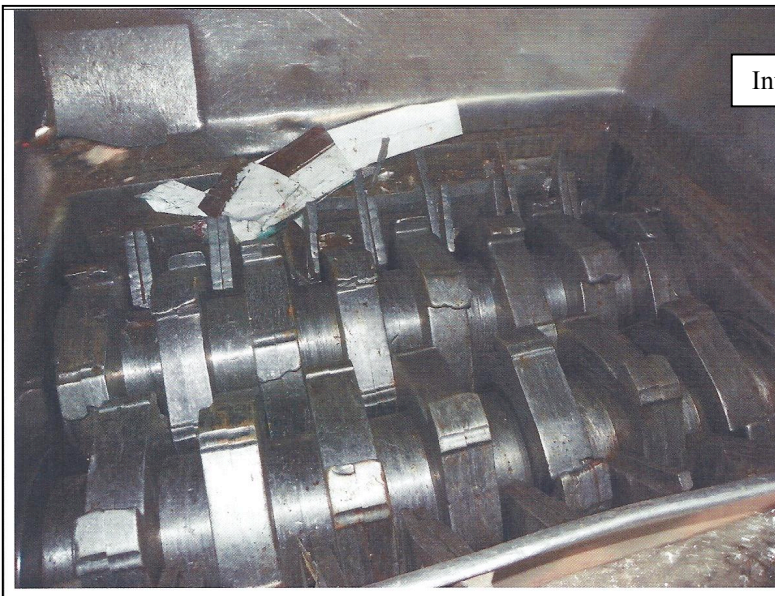
Interior of shredder as viewed from ledge.
