20 Fall through floor opening – Inspection #1164863

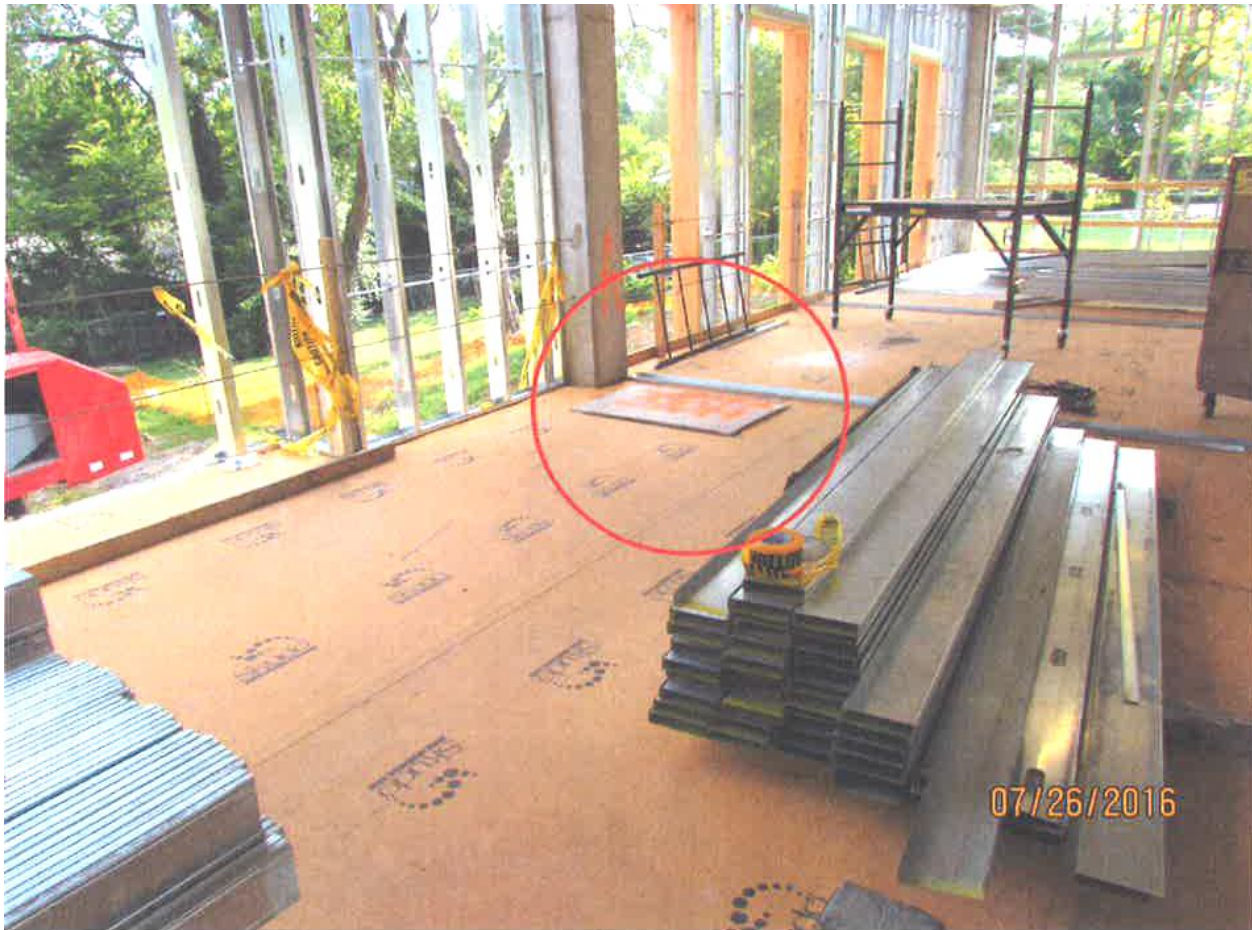
Photo 1 of 2 – The red circle indicates where the floor opening was located near the windows.

29 CFR 1926.502(i)(3)	All covers were not secured when installed so as to prevent accidental displacement by the wind, equipment, or employees. In that a hole cover located on the main level of the building was not secured to prevent it from being accidentally displaced. An employee was able to move the cover and fall through the hole 15 feet to the basement level below.
-----------------------	---

29 CFR 1926.502(i)(4)	All covers were not color coded or marked with the work “HOLE” or “COVER” to provide warning of the hazard. In that the cover for a hole located on the main floor was not color coded or marked with the work “HOLE” or “COVER”. An employee moved the cover and fell through the hole 15 feet to the basement level.
-----------------------	--

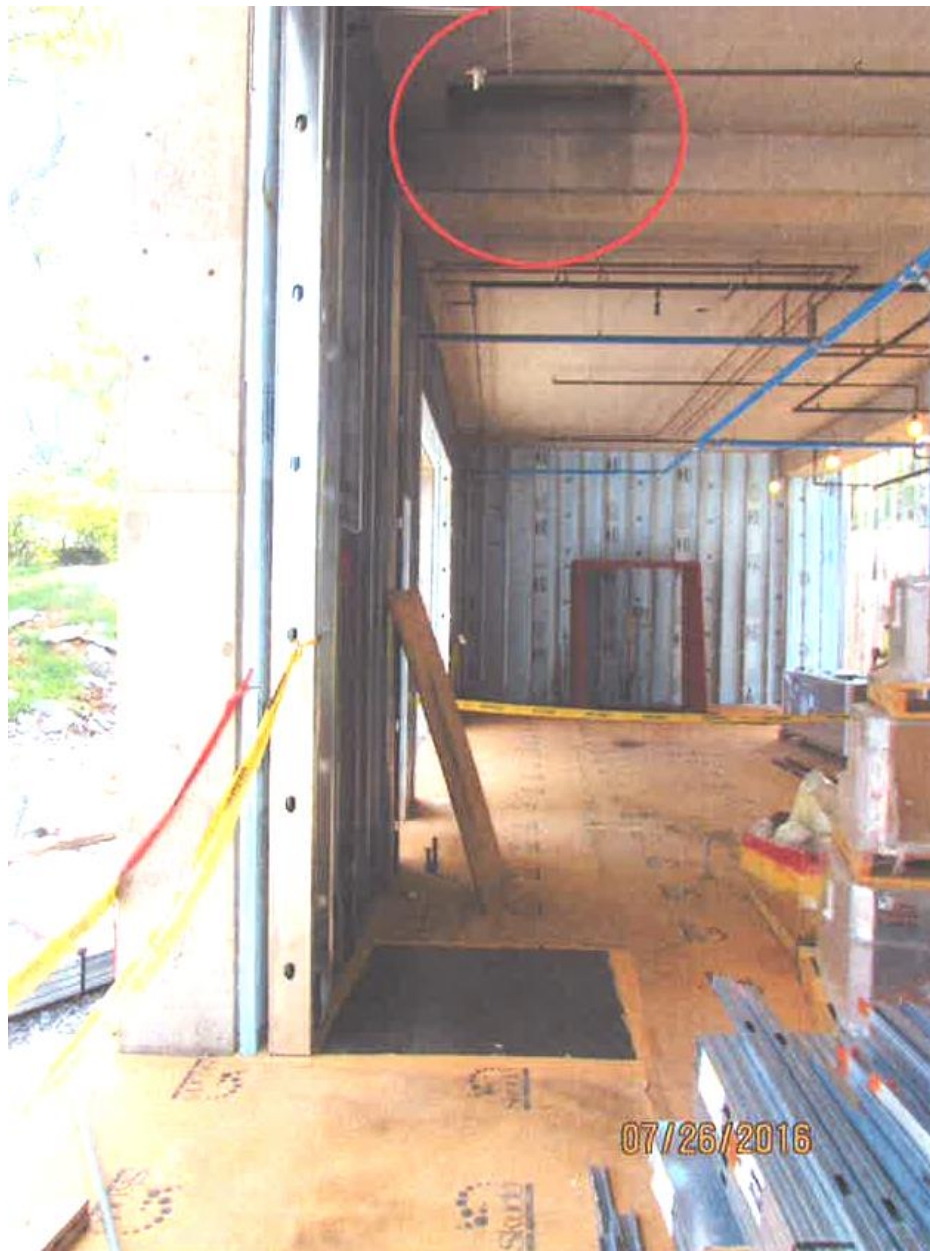
Photo 2 of 2 – The red circle indicates where the victim fell through the floor opening cover into the basement below.
