7 Crushed by trench collapse—Inspection # 1390141 Spencer Utility Dept

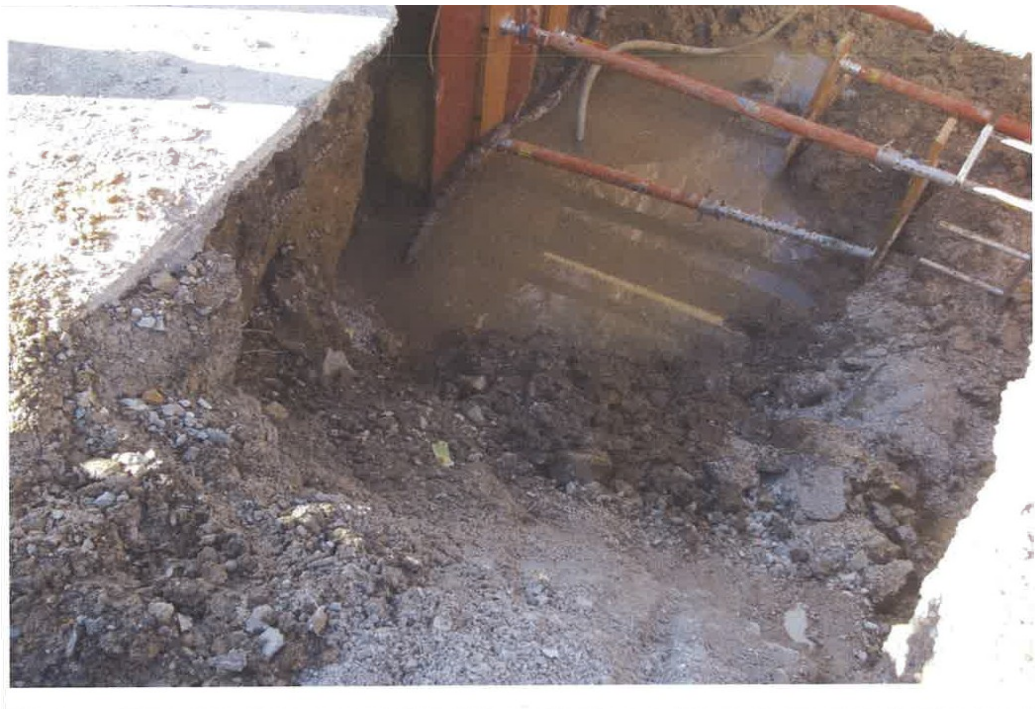
It was determined that the victim was going to be the operator's (other employee) "eyes" while more dirt was dug out of the trench. The victim had been in the trench for approximately 30 minutes working on the leak when the trench collapsed. Interviews of employees on site indicated that the victim was standing with a shovel under the track hoe while it dug on the east side of the trench. It was stated that when the operator scooped the bucket, the east side of the trench wall collapsed.

PICTURES TAKEN AFTER COLLAPSE DURING THE RESCUE PHASE.

**29 CFR 1926.652(a)(1):** Each employee in an excavation was not protected from cave-ins by an adequate protective system designed in accordance with paragraph (b) or (c) of this section:

On 4/2/19, an employee was exposed to engulfment and struck-by hazards while working in a 10-foot deep trench on Phifer Mine Road that did not have adequate cave-in protection.
