A **28 year old male** employee was **crushed by** a mobile home when it shifted off cribbing while in the process of installing vapor barrier underneath it during set up on a private lot.

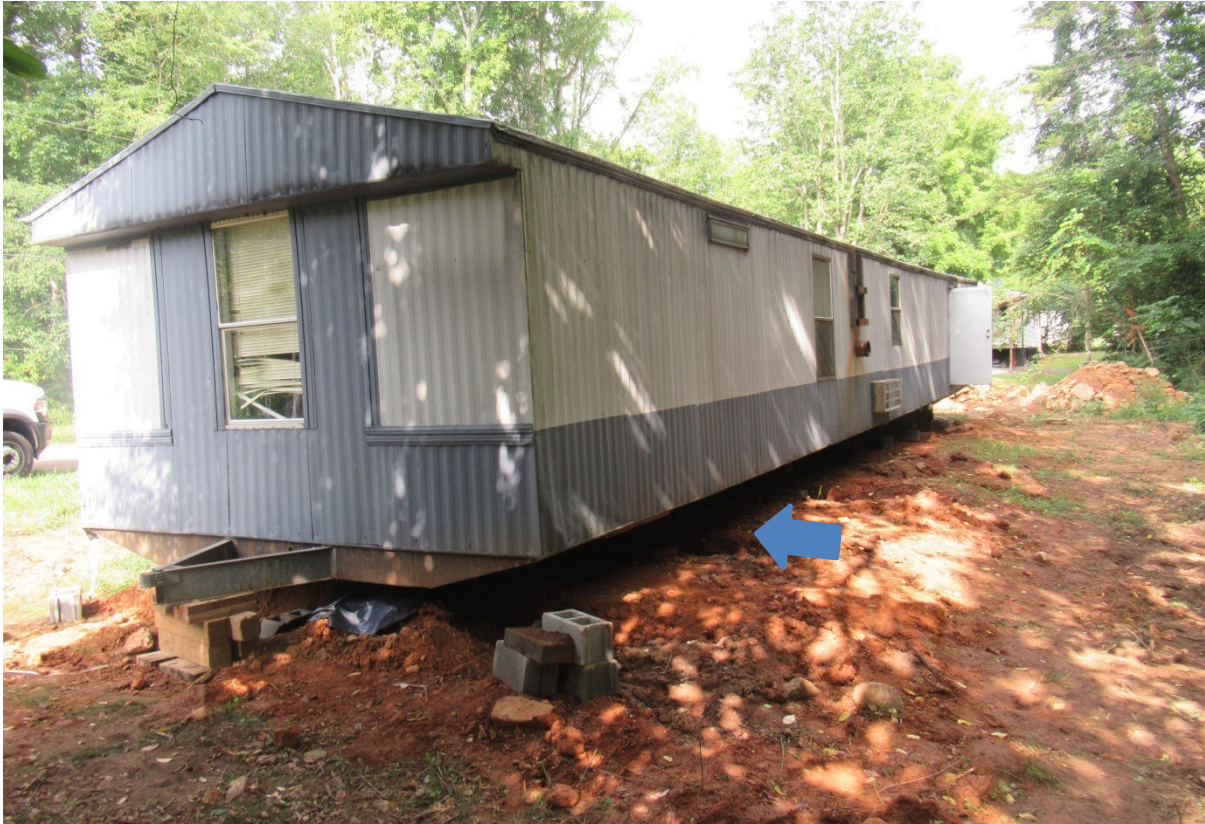
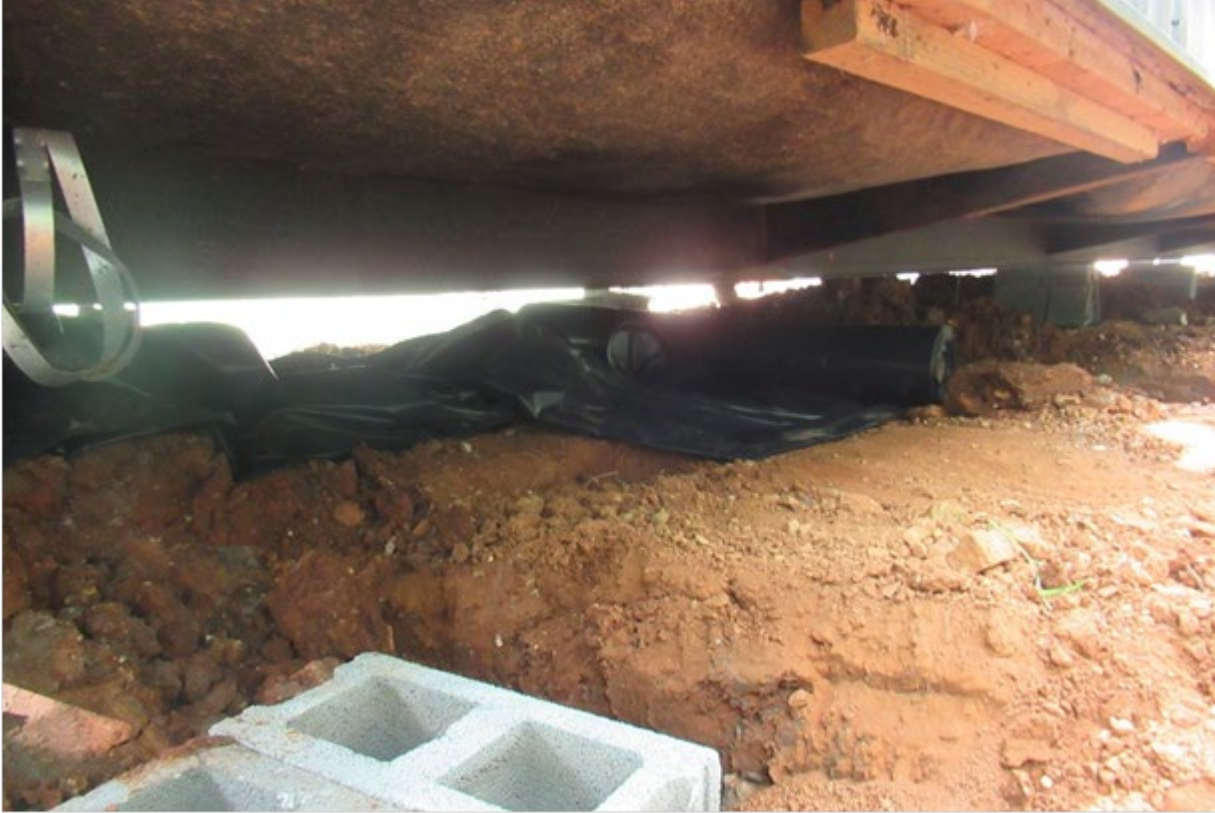
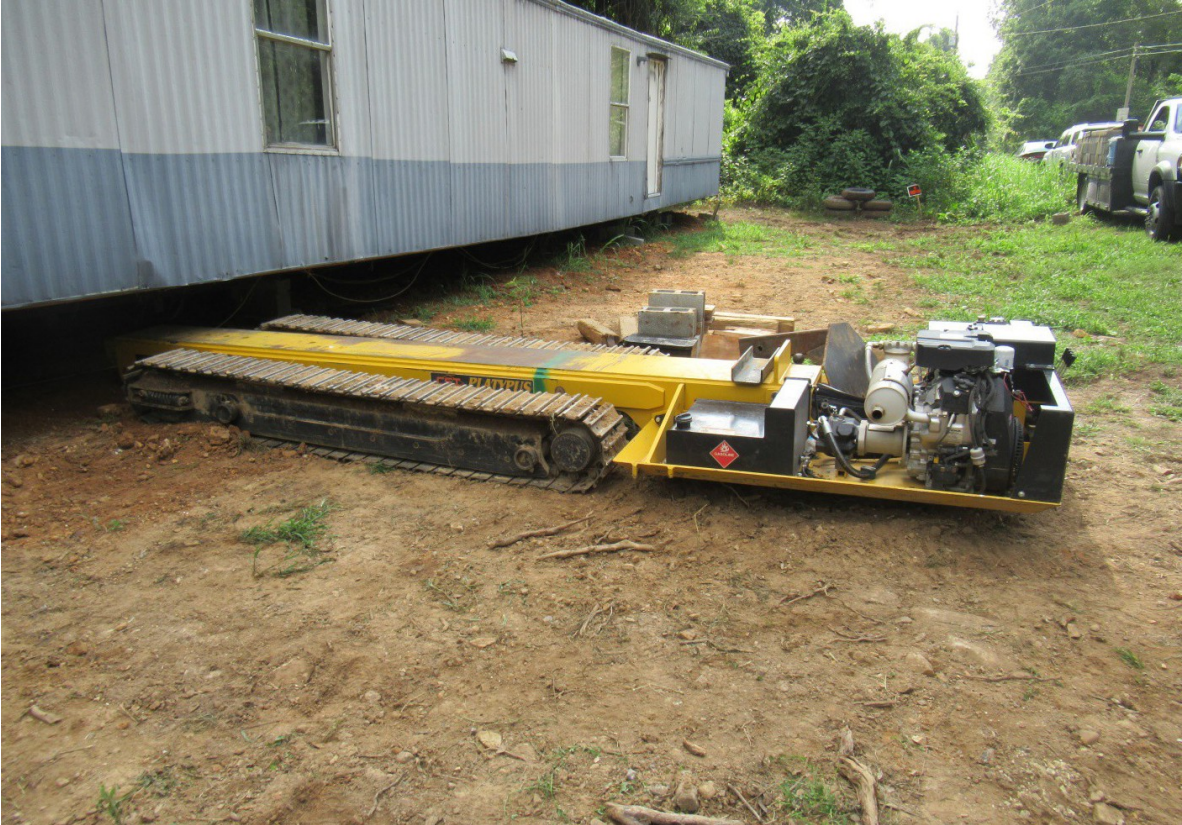
With the wheels and axles still in place on the mobile home, the Platypus was used to lift the east end (on the south side) of the home in order to construct wood cribbing under the tongue of the mobile home. The wood cribbing consisted of three, 16" x 6" x 2" thick base boards. On top of the base boards were six, 3' x 4.5" boards stacked alternating to form a square with two, 16" x 6" x 2" boards on top. After the cribbing was in place the mobile home was lowered onto it. Once the home was resting on the cribbing the employees used a shop fabricated water level to ensure that the mobile home was level and at approximately 28 inches above the ground.

The victim was working under the home on the northeast side approximately 8' from the employee and foreman re-leveling the home at the tongue and 54 feet from the Platypus. The employee and foreman re-leveling the home used a Pittsburgh Heavy Duty 12 ton bottle jack placed on a wood 1" thick board to attempt to lift the home off of the wood cribbing. The foreman told the victim to get out from underneath the home. Without the victim moving from underneath the home, the employee and foreman began using the bottle jack to lift the home from its cribbing. The bottle jack started to sink into the ground without lifting the mobile home. Once again, the foreman told the victim to exit from underneath the mobile home. The jack was lowered back down, and the employee working with the foreman went to go get a 2" thick board from the work truck to place under the jack to prevent it from sinking into the ground. It was at this moment the home began to shift while resting on the wood cribbing, falling completely from its cribbing and crushing the employee beneath the home, resulting in the fatality.

- a) Writing, training, implementing, and enforcing a work procedure prohibiting employees to work under the trailer while still setting the mobile home.
- b) Implementing a verbal and visual confirmation system to ensure that no employee is under the mobile home prior to performing work on the mobile home.
