A **49 year old male** employee working as a wire technician **fell approximately 19' from a ladder** while attempting to install fiberoptic cable to a private residence. This employer installs telecommunication equipment to residential and commercial facilities.

Fall from ladder--Insp # 1525984 AT & T Tennessee

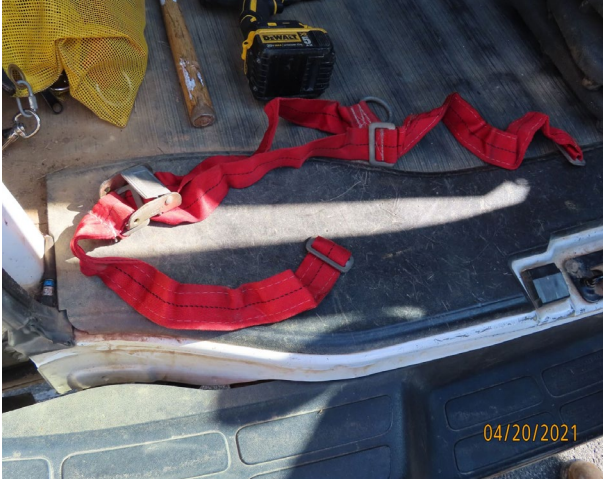
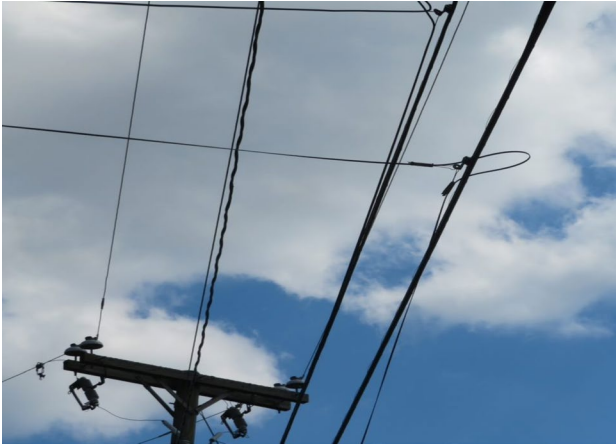
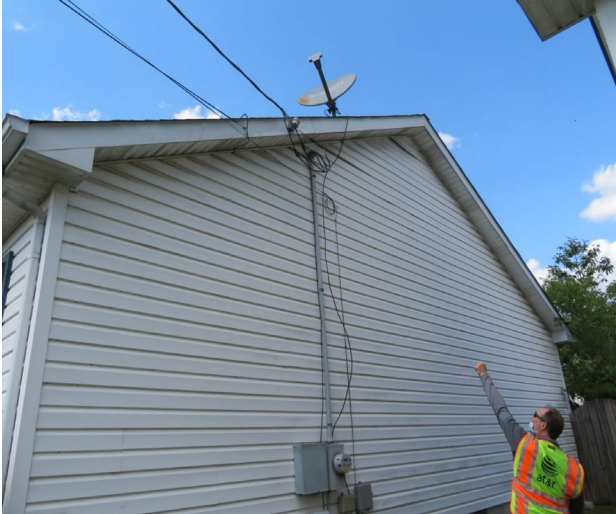
It is believed that when the victim climbed the ladder, his weight caused the strand to flex in the direction he was facing. The flex in the strand added tension to the copper line that was still attached to the home which caused the line to rip from the home. The strand and the copper line are two different lines attached at the midspan allowing the copper line to deviate from the strand's direction. The ladder was leaned onto the strand where the copper line was run parallel with the stand. The strand then flexed more with the weight of the victim. When the strand flexed to its farthest point, the strand was pushed back in the opposite direction throwing the employee from the ladder to the ground. The victim was found unconscious on the ground and transported to the hospital where he eventually succumbed to his injuries
