A **72 year old male** employee was **struck by a dump truck** while working as a flagger directing traffic on a construction site.

Struck by vehicle--Insp # 1521184 Safe Zone, LLC

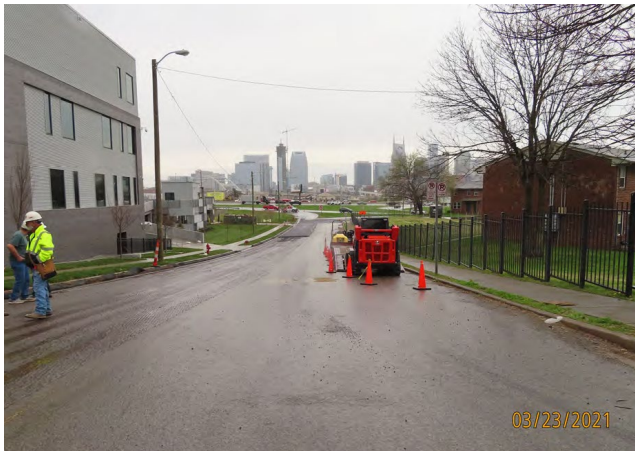
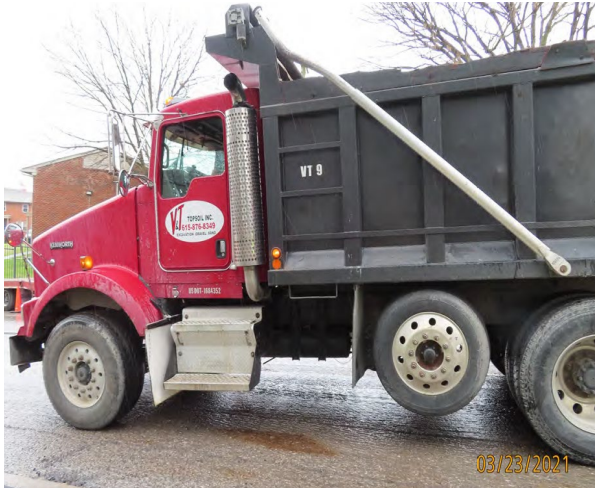
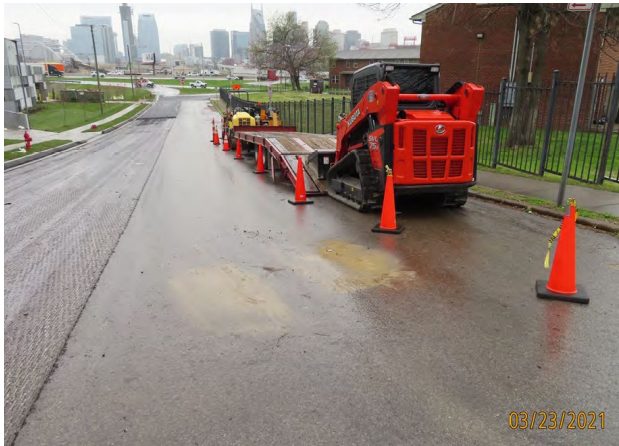
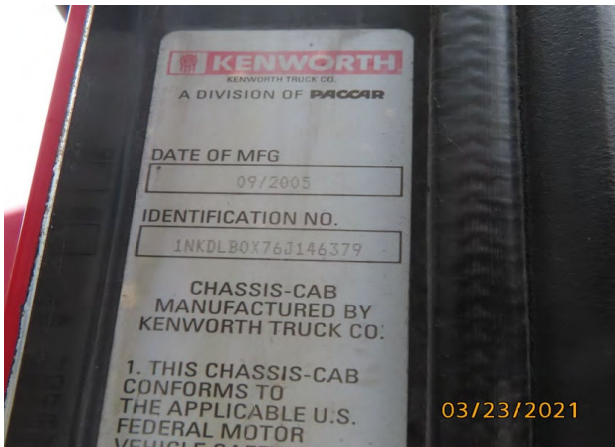
At the time of the accident, asphalt was being paved at the beginning of Jerry Newsome Way and the I-24 ramp. Asphalt dump trucks were staged at the corner of 710 South 5th Street to enter Jerry Newsome Way.

According to interviews, the traffic control flaggers moved the cones and started directing traffic on 5th Street. Before the Asphalt dump truck started to back down Jerry Newsome Way, the driver allowed another vehicle to move at the intersection and one flagger stopped traffic along 5th Street. As the asphalt dump truck driver started backing down Jerry Newsome Way, he noticed, in his driver's side mirror, a trailer bed and backhoe parked on the right side of the road approximately 60 feet from 5th Street. The driver backed the truck up at an angle to miss them. The driver was on the milled part of the asphalt which he stated made a rumble and he continued to back down Jerry Newsom Way until he reached the paver. When he got to the paver, the driver signaled with his hands to unlock the dump truck tail gate. The paver then looked up and saw the victim laying in the road. The dump truck driver stated that he only saw one flagger and he was on the road directing traffic. He stated that the 2nd flagger (victim) was not seen.

The dump truck's backup alarm and safety lights were working at the time of the accident; however, was not equipped with mechanical backing assistive devices such as collision avoidance or proximity warning systems (radar) or monitoring technologies (e.g., cameras), which may increase the likelihood that operators will detect workers on foot. A spotter was not used either.

In that an employee was struck-by a backing dump truck. The employer failed to implement and communicate to all dump truck operators and all other workers an Internal Traffic Control Plan (ITCP).
