Fall through skylight —Insp # 1641715 Tennessee Valley Railroad

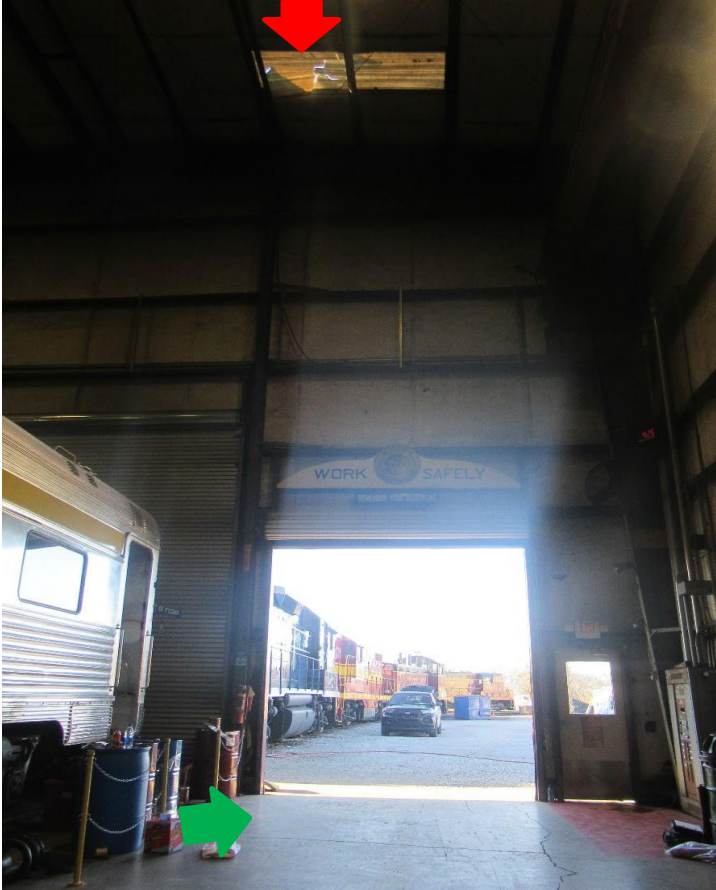
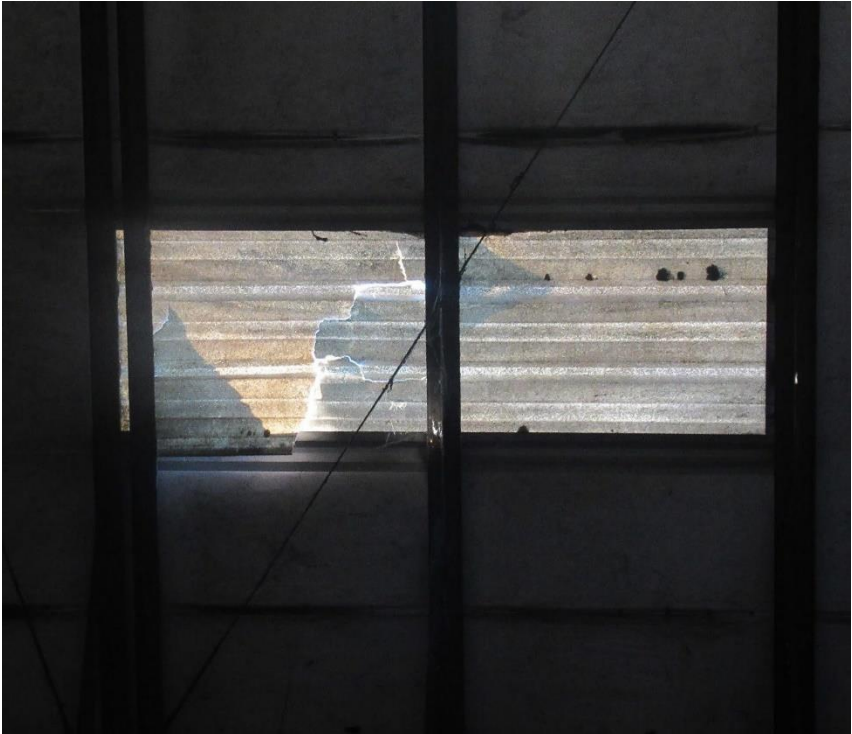
In conclusion, the victim was trying to repair the roof because it was leaking. The victim did not have fall protection on, and the skylights on the roof were not guarded. The victim fell through the northeastern most skylight approximately 37 feet and sustained fatal injuries on site. The employer did not ensure that employees were protected while operating an aerial lift, working at heights six feet or greater, and that the skylights were properly guarded/covered.

In that the fiberglass skylights on the roof were not guarded before an employee fixed the roof leaks, exposing an employee to an approximate 37-foot fall hazard that resulted in a fatality.
