Thrown from & crushed by skid steer – Inspection #1072840

A **38 year old male** employee was fatally injured when he was ejected from a skid steer. The victim was contracted by the controlling contractor for storm debris removal after an ice storm in Cumberland County. A Manitou Telehandler skid steer, with a grab bucket, was provided by the controlling contract and operated by the victim. The victim and his crew had been working on this project for approximately four weeks prior to the accident. On the day of the accident the victim was operating the Manitou downhill on a two lane highway when the drive shaft broke. It is believed the victim thought he could safely come to a stop by steering the Manitou off the road into a yard adjacent to the highway. A ditch running parallel to the highway was concealed from the operators view by overgrown grass and weeds. The Manitou gained momentum as it traveled down the hill, left the road, and hit the ditch. The out of control the Manitou traveled further in the yard hitting a second ditch and then a tree before coming to rest on its left side. The victim was ejected. There were no skid marks on the highway to indicate the victim applied

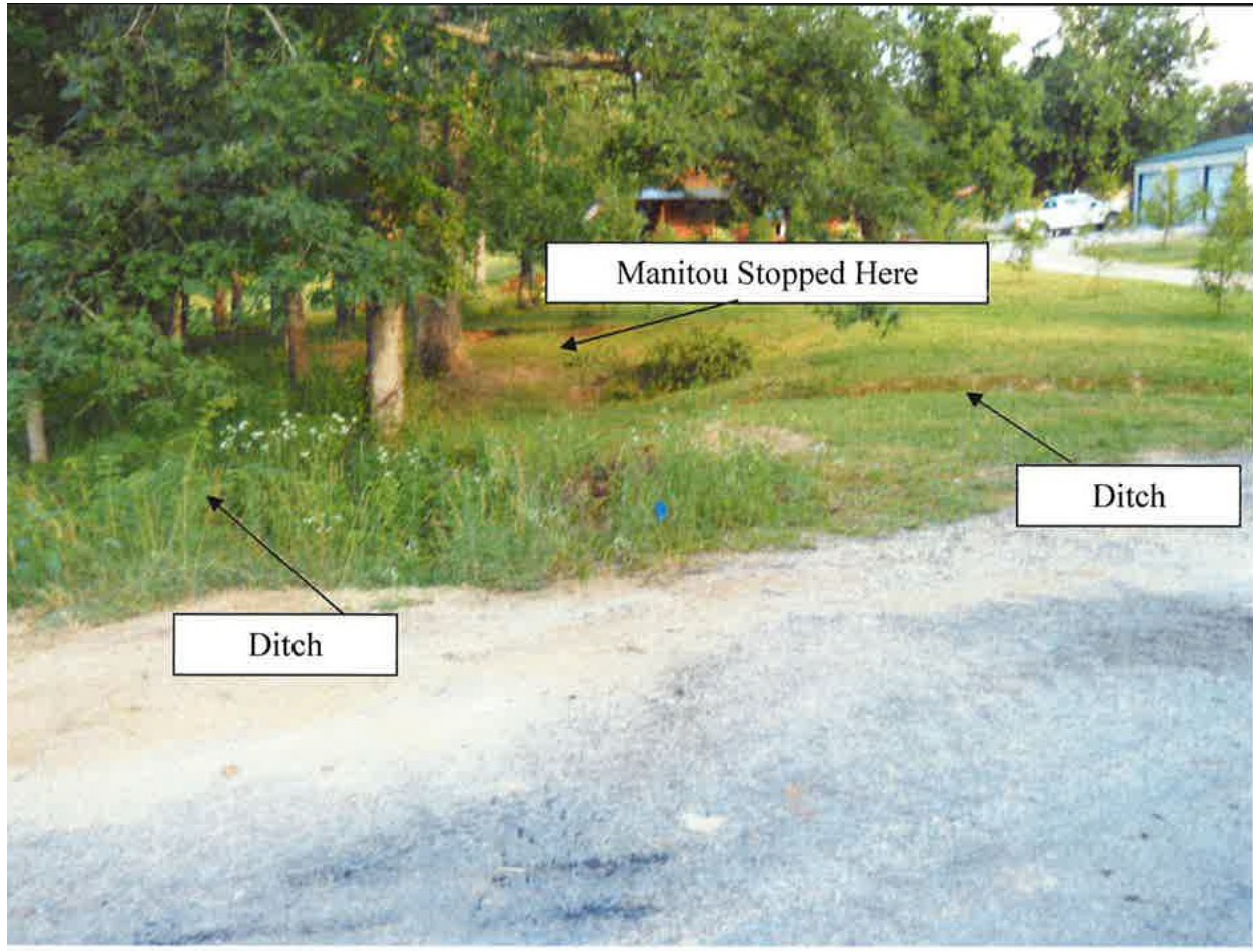
Photo 1 of 2 – This photo shows where the skid steer rolled over on its side and the ditch that was involved with the crash.

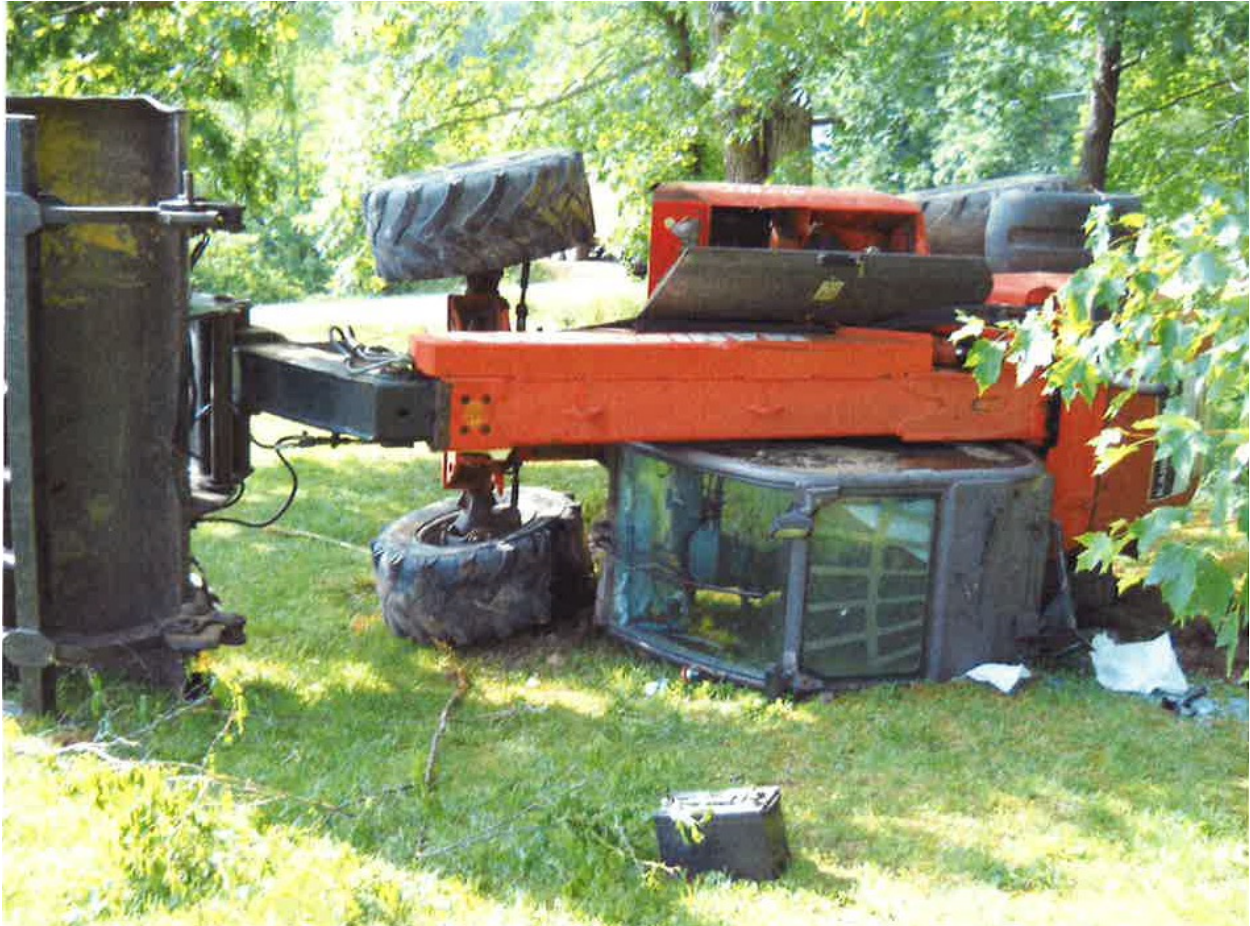
Photo 2 of 2 – This photo shows where the skid steer rolled over on its left side.
