31 Trench collapse – Inspection #1273639

A **42 year old male** employee was fatally injured when the trench wall caved-in on him. The victim was in a 5 foot deep trench installing pipe to tie into the existing main sewer line. The company had been contracted to install a bathroom sewer line for the new construction gymnasium. The Foreman had dug the trench and set the pipe into the trench using a track hoe. The victim then entered the trench to connect the new sewer pipe into the existing line. The victim was in the trench for approximately 5 minutes when the trench wall caved-in on him. The investigation revealed that the spoil pile was located at the edge of the trench on both sides which created extra weight on the walls and likely contributed to the wall collapsing. The 5 foot deep trench did not have any type of cave-in protection.

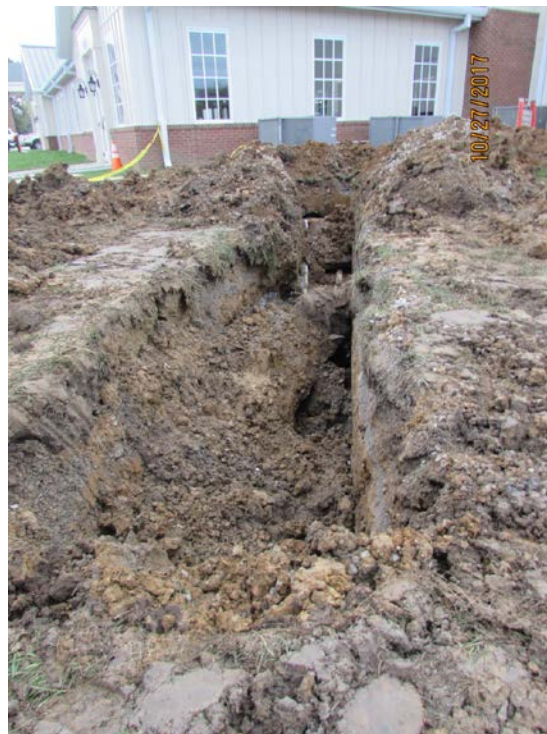
Photo 1 of 1 – Photo shows the collapsed trench.
