## 9- struck by ceiling collapse --Inspection # 1406639 Demo Plus

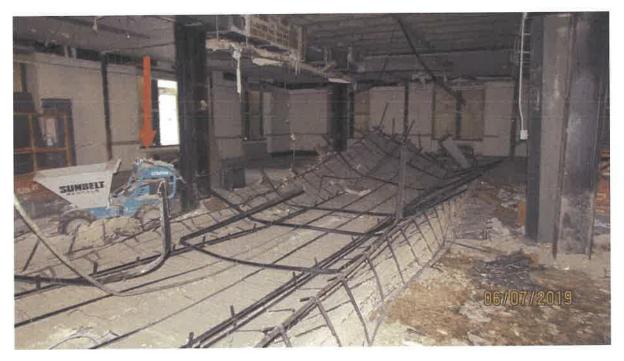
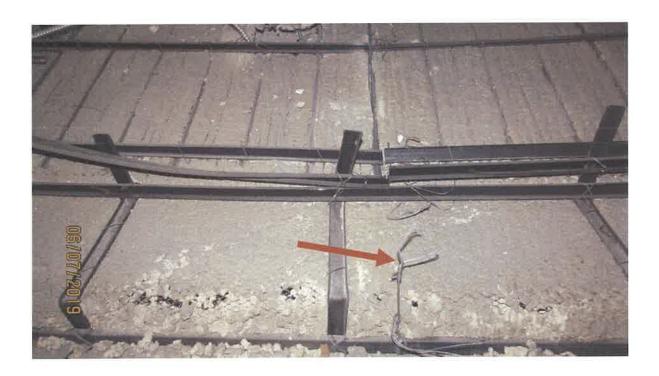
It was found that employees working in the area where the accident occurred were performing demolition tasks. Walls were demoed with the help of a Sherpa demo machine and the use of sledge hammers. A large section of the plaster ceiling that was directly attached to the concrete structure had also been removed. The employees were using reciprocating saw(s), grinders and metal sheers to cut through the plaster ceiling. They would remove 2 foot wide strips of the ceiling at a time until they removed the entire 35 feet of the ceiling. This left the section of suspended ceiling that fell supported only by metal tie-wires that were connected to tabs in the concrete structure at various points. At the time of the accident they were working on the floor and the victim was removing the debris. As the employees were removing flooring and chipping concrete with a jack hammer, the section of suspended plaster ceiling fell onto the victim.

According to the employer this section of ceiling weighed approximately 4 to 5 thousand pounds and was measured to be 35 feet long and 10 feet wide. Through employer/employee interviews it was learned that there was no shoring or bracing supporting the suspended ceiling as walls had been removed and sections of the ceiling were cut away. It was also determined that the employer did not have a competent person inspecting the work throughout the job to ensure unsafe conditions were not being created as the work progressed.

In that an employee was allowed to work underneath the suspended plaster ceiling with it only being supported by metal tie-wires connected to tabs in the concrete structure.

In that inspections of the jobsite were not being conducted, throughout the demolition process, by a competent person, to ensure the employees were not exposed to hazards from weakened or deteriorated floors, walls or loosened material.
