### 3 Crushed by equipment--insp#1468412 Head Equipment

A **30 year old male** was **crushed** between the cab/counterweight of a John Deere 790D LC excavator and a piece he had cut off of the base of the excavator for salvage.

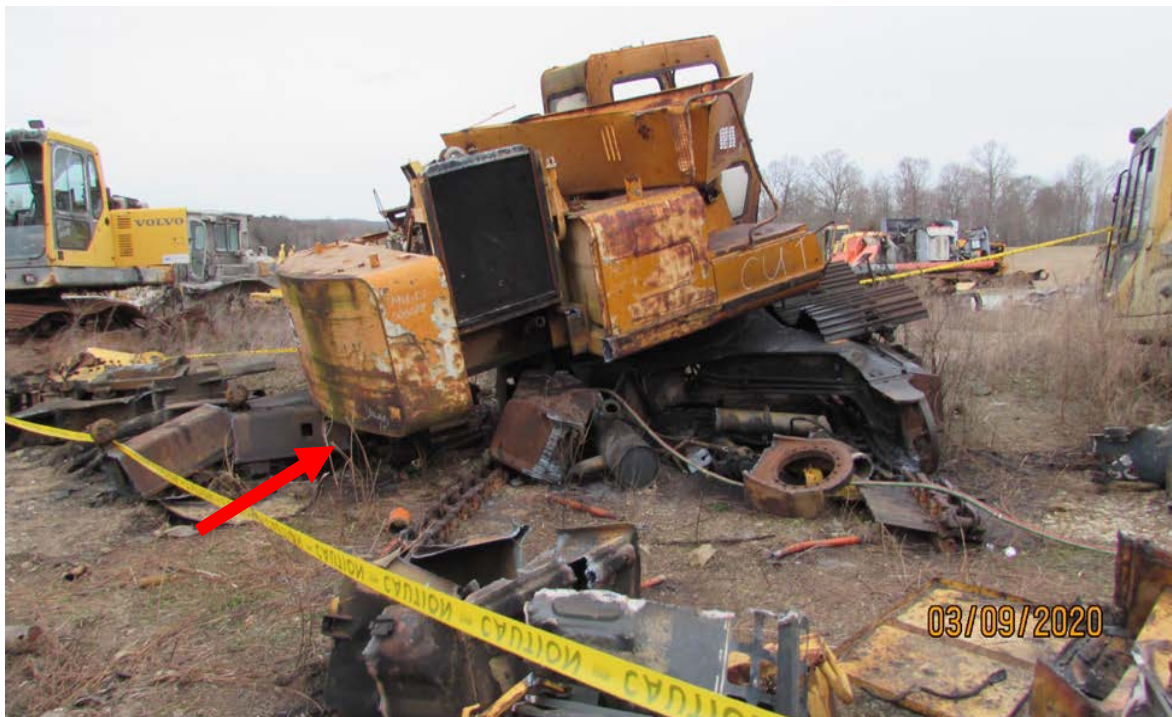
During the inspection, the excavator involved in the fatality was observed. It appeared that the safety systems (hydraulic lines, brake system, and springs, etc.) used to secure and stabilize the cab from rotating had been removed for salvageable purposes. Also it was noted that the machine was sitting on a rolling hill in the yard which put it at an angle and not on a level surface.

It is presumed that while the victim used the cutting torch to dismantle it, the excavator shifted allowing the cab to spin striking the victim then pinning him underneath it. He was working alone at the time of the incident.

- a) use a secondary means of supporting the heavy equipment while an employee is cutting it into smaller pieces,
- b) develop and implement procedures for employees to follow to ensure the safe removal of parts from heavy equipment,
- c) stage the piece of equipment to be cut up on a level surface during the cutting process to prevent movement and/or tip over,
- d) keep the hydraulic braking system and springs connected to prevent the cab from free spinning
